blue[®]m, for the protection of injured periodontal tissue

Peri-implantitis of the 4.5 : A 3 year follow -up

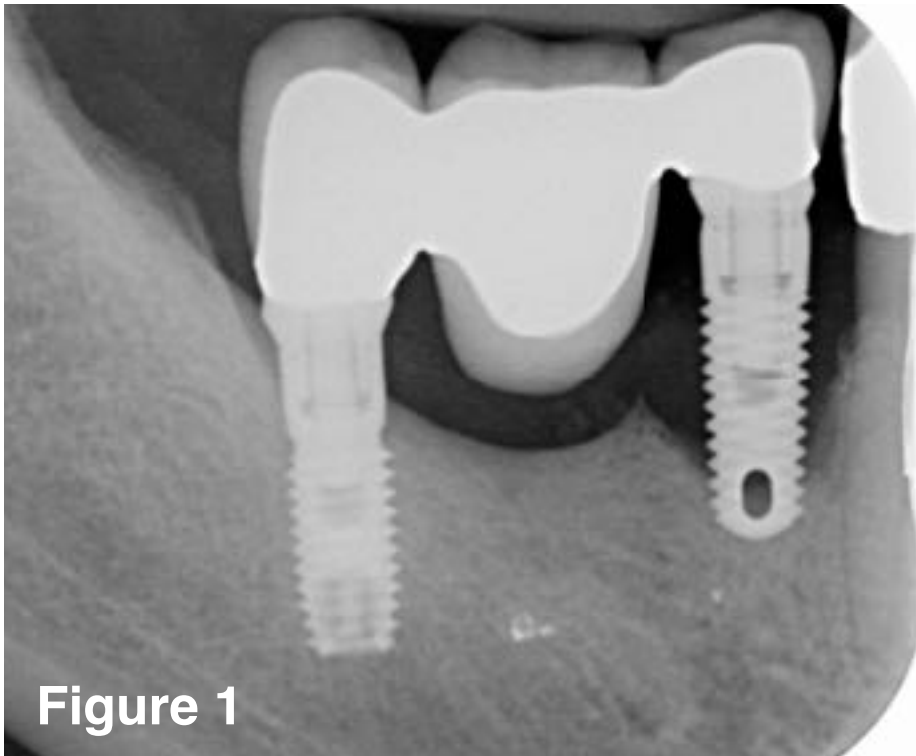
Figure 1

X-ray date: 21-08-2014

- Female patient, smoker
- Patient had implant placement in 2010. Implant was placed in supraposition because of the location of the nervus mentalis and therefore was never completely subgingivally integrated in the bone
- DNA bacterial test showed a high concentration of PG
- Therapy: AB metronidazole 500mg 3x1p/d for 7 days in combination with flap surgery on the 45

The implant 45 shown on the X-Ray of 21-08-2014 (Figure 1) and on the X-Ray of 27-06-2017 (Figure 4)
